## Item #356190 - 2008 Terex T 775 Hydraulic Truck Crane

# Inspection Report

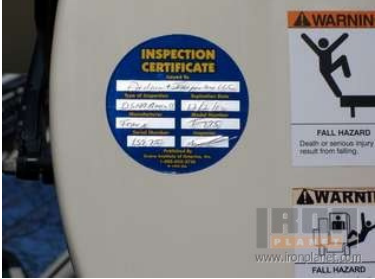
Safety Certification Label	Yes

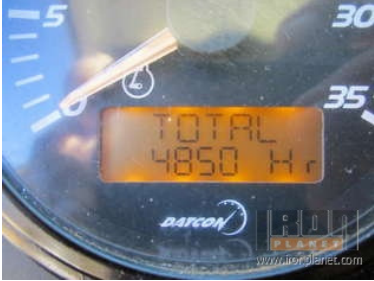
Control Station Carrier		
Item	Assessment	Photo
Mirrors	☆☆☆☆ No visible damage	
Glass	☆☆☆☆ No visible damage	
Seats/Armrests	☆☆☆☆	
Seat Belts	Operational	
Horn	Inoperable	
Steering Controls	☆☆☆☆	
Drivetrain Controls	☆☆☆☆	
Oil Pressure	The fault indicator shuts off after the engine oil pressure rises.	
Exterior Lights Operational	Yes	
Engine Warning Lights	Operational	
Gauges	Operational	
Hour Meter/Odometer	4850. Hours; 0 Miles; Operational hour meter; Inoperable odometer

Heater	Operational	
Limited Function Check	The main components are in place and operational.	
Control Station Carrier #1

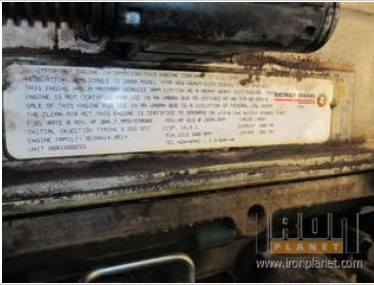
Engine - Carrier		
Item	Assessment	Photo
Make and Model	Detroit Series 60	
Fuel Type	Diesel	
Emission Control Label	US EPA certification label

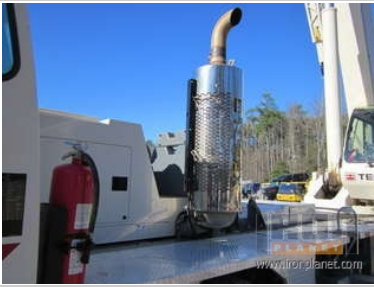
Starter	Operational	
Turbo or Blower	Operational	
Injector Pump	Operational	
Exhaust System	No visible damage	
Radiator	☆☆☆☆☆	
Oil Leaks	There is fluid accumulation around the valve cover and on the side of the engine.	
Fuel Leaks	None seen	
Cooling System Leaks	None seen	
Air Compressor	☆☆☆☆☆ Operational	
Limited Function Check	The engine started and ran. See oil report.	
Engine - Carrier #1

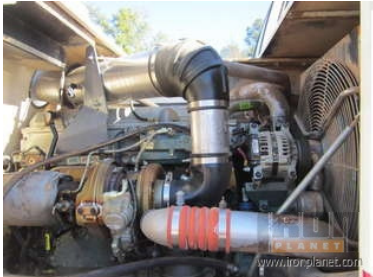
Engine - Carrier #2

A photograph showing a close-up view of the engine compartment of a truck crane. The engine is a large, complex piece of machinery with various pipes, hoses, and components. A prominent red and white striped hose is visible in the foreground.
Engine - Carrier #3

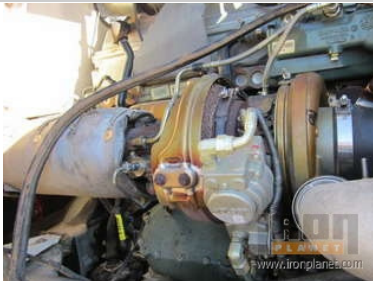
A photograph showing a close-up view of the engine compartment, focusing on the upper part of the engine and various hoses and components.
Engine - Carrier #4

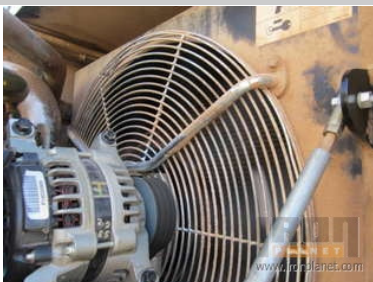
A photograph showing a close-up view of the engine compartment, featuring a large, circular, ribbed fan or radiator component.
Engine - Carrier #5

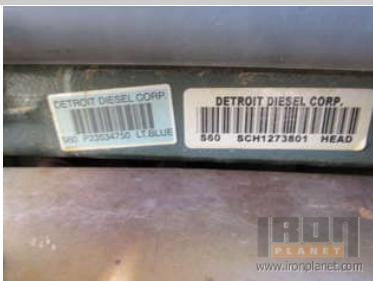
A photograph showing two white labels with black text and barcodes. The left label reads "DETROIT DIESEL CORP." and "SER. 133034700 LT.BLU". The right label reads "DETROIT DIESEL CORP." and "660 SCHT273801 HEAD".
Engine - Carrier #6

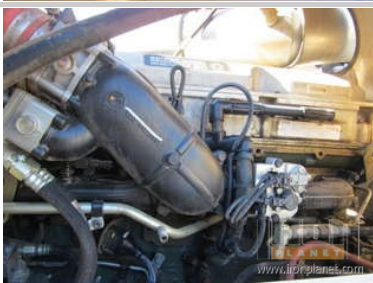
A photograph showing a close-up view of the engine compartment, focusing on the lower part of the engine and various hoses and components.

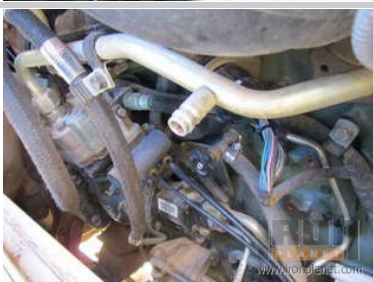
Engine - Carrier #7

A photograph showing a close-up view of the engine compartment, focusing on the lower part of the engine and various hoses and components.
Engine - Carrier #8

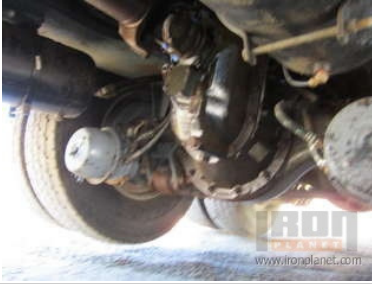
Drivetrain - Carrier		
Item	Assessment	Photo
Transmission Type	7 speed Allison automatic	
Transmission	★★★★☆ Operational; Fluid Accumulation	
Center Drive Axle	★★★★☆	
Rear Drive Axle	★★★★☆	
Limited Function Check - Carrier	The drivetrain was operational without a load. See oil report.	
Drivetrain - Carrier #1

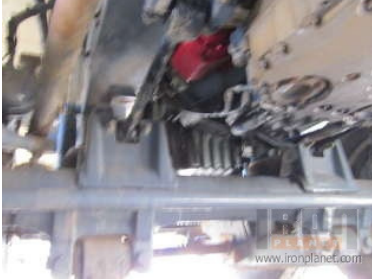
Chassis		
Item	Assessment	Photo
Steering Linkage	★★★☆☆ Minor to moderate movement	
Steering Wheel Play	Minor to moderate movement	
Brake Type	Air	
Master Cylinder/Brake Control	★★★☆☆	
Brake Lines/Hoses	★★★☆☆	
Park Brake	★★★☆☆ Stopped the machine w hile rolling	
Limited Function Check	The brake system functioned, stopping and holding the machine.	
Springs/Hangers Condition	★★★☆☆	
Suspension Air Bags	★★★☆☆	
Frame Condition	★★★☆☆	
Cross Members	★★★☆☆	
Tire Size	445/65R22.5 Front tires; 315/80R225 Rear tires; ALL MICHELIN	
Tire Condition	Minor cuts and gouges	
Tread Depth	LF 20,21 /32"; RF 20,25 /32"; RMO 15 /32"; RMI 20 /32"; LMI 11 /32"; LMO 11 /32"; RRO 7 /32"; RRI 7 /32"; LRI 10 /32"; LRO 10 /32"	
Wheel Condition	★★★☆☆ All Aluminum	
Wheel Studs	★★★☆☆	
Outrigger Beams	★★★☆☆	
Outrigger Cylinders	★★★☆☆	
Outrigger Pads	★★★☆☆	
Main Boom Pins	★★★☆☆ Minimal movement	
Main Boom Sections	★★★☆☆ Boom dolly brackets have been removed.

Sheaves	★★★☆☆	
Boom Head Section	★★★☆☆	
Boom Extension Condition	★★★☆☆	
Wear Pads	★★★☆☆ Minor to moderate movement	
Boom Length	126' Extended boom length; 40' Minimum boom length; 57' jib (extended) 32' jib (retracted)	
Boom/Jib Extension	★★★☆☆ 57' Long; Sw ing Aw ay (side mounted)	
Boom Angle Indicator	★★★☆☆	
Turn-table Bearing	★★★☆☆	
Bottom Covers	★★★☆☆	
Limited Function Check (rough terrain)	The main crane components functioned w hen checked w ithout a load.

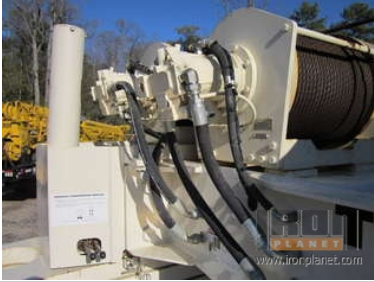
Hydraulics #2

Hydraulics		
Item	Assessment	Photo
Pumps (Hydraulics)	☆☆☆☆ Fluid accumulation	
Hydraulic Motors	☆☆☆☆	
Valves	☆☆☆☆ Fluid accumulation	
Hydraulic Tank	☆☆☆☆	
Hoses (Hydraulic)	☆☆☆☆	
Sw ing Motor	☆☆☆☆	
Main Hoist	☆☆☆☆	
Auxiliary Hoist	☆☆☆☆	
Lift Cylinders	☆☆☆☆ Fluid accumulation	
Telescope Boom Cylinders	☆☆☆☆	
Cylinder Pins and Bushings	☆☆☆☆ Minor to moderate movement	
Limited Function Check	The hydraulic system w as operational without a load. See oil report.	
Hydraulics #1

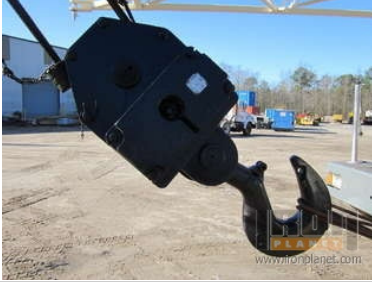
Specialty - Crane																														
Item	Assessment	Photo																												
Main Load Block	<p>★ ★ ☆ ☆</p> <p>JOHNSON brand load block; Model: QRJ750N16RTC; 75 TON capacity load block; Safety latch missing</p>																													
Overhaul Ball	<p>★ ★ ★ ☆</p> <p>Brand: JOHNSON; Capacity: UNKNOWN; Minor wear; Moderate wear</p>																													
Specialty - Crane #1
